SUBJECT: PHASE I GEOLOGIC FAULT INVESTIGATION FOR A WATERLINE THAT
WILL PASS ALONG MONROE ROAD BETWEEN AIRPORT BOULEVARD AND
ALMEDA GENOA ROAD, SOUTHEAST HOUSTON, TEXAS.

**PHASE I GEOLOGICAL FAULT INVESTIGATION OF MONROE ROAD
BETWEEN AIRPORT BOULEVARD AND ALMEDA GENOA ROAD
SOUTHEAST HOUSTON, TEXAS**

PROPOSED BORING LOCATION PLAN
 66-INCH WATER LINE ALONG MONROE RD. AND ALAMEDA-GENOA RD.
 FROM MOERS RD. TO AIRPORT BLVD., SWTP CONTRACT 70A-4
 HOUSTON, TEXAS

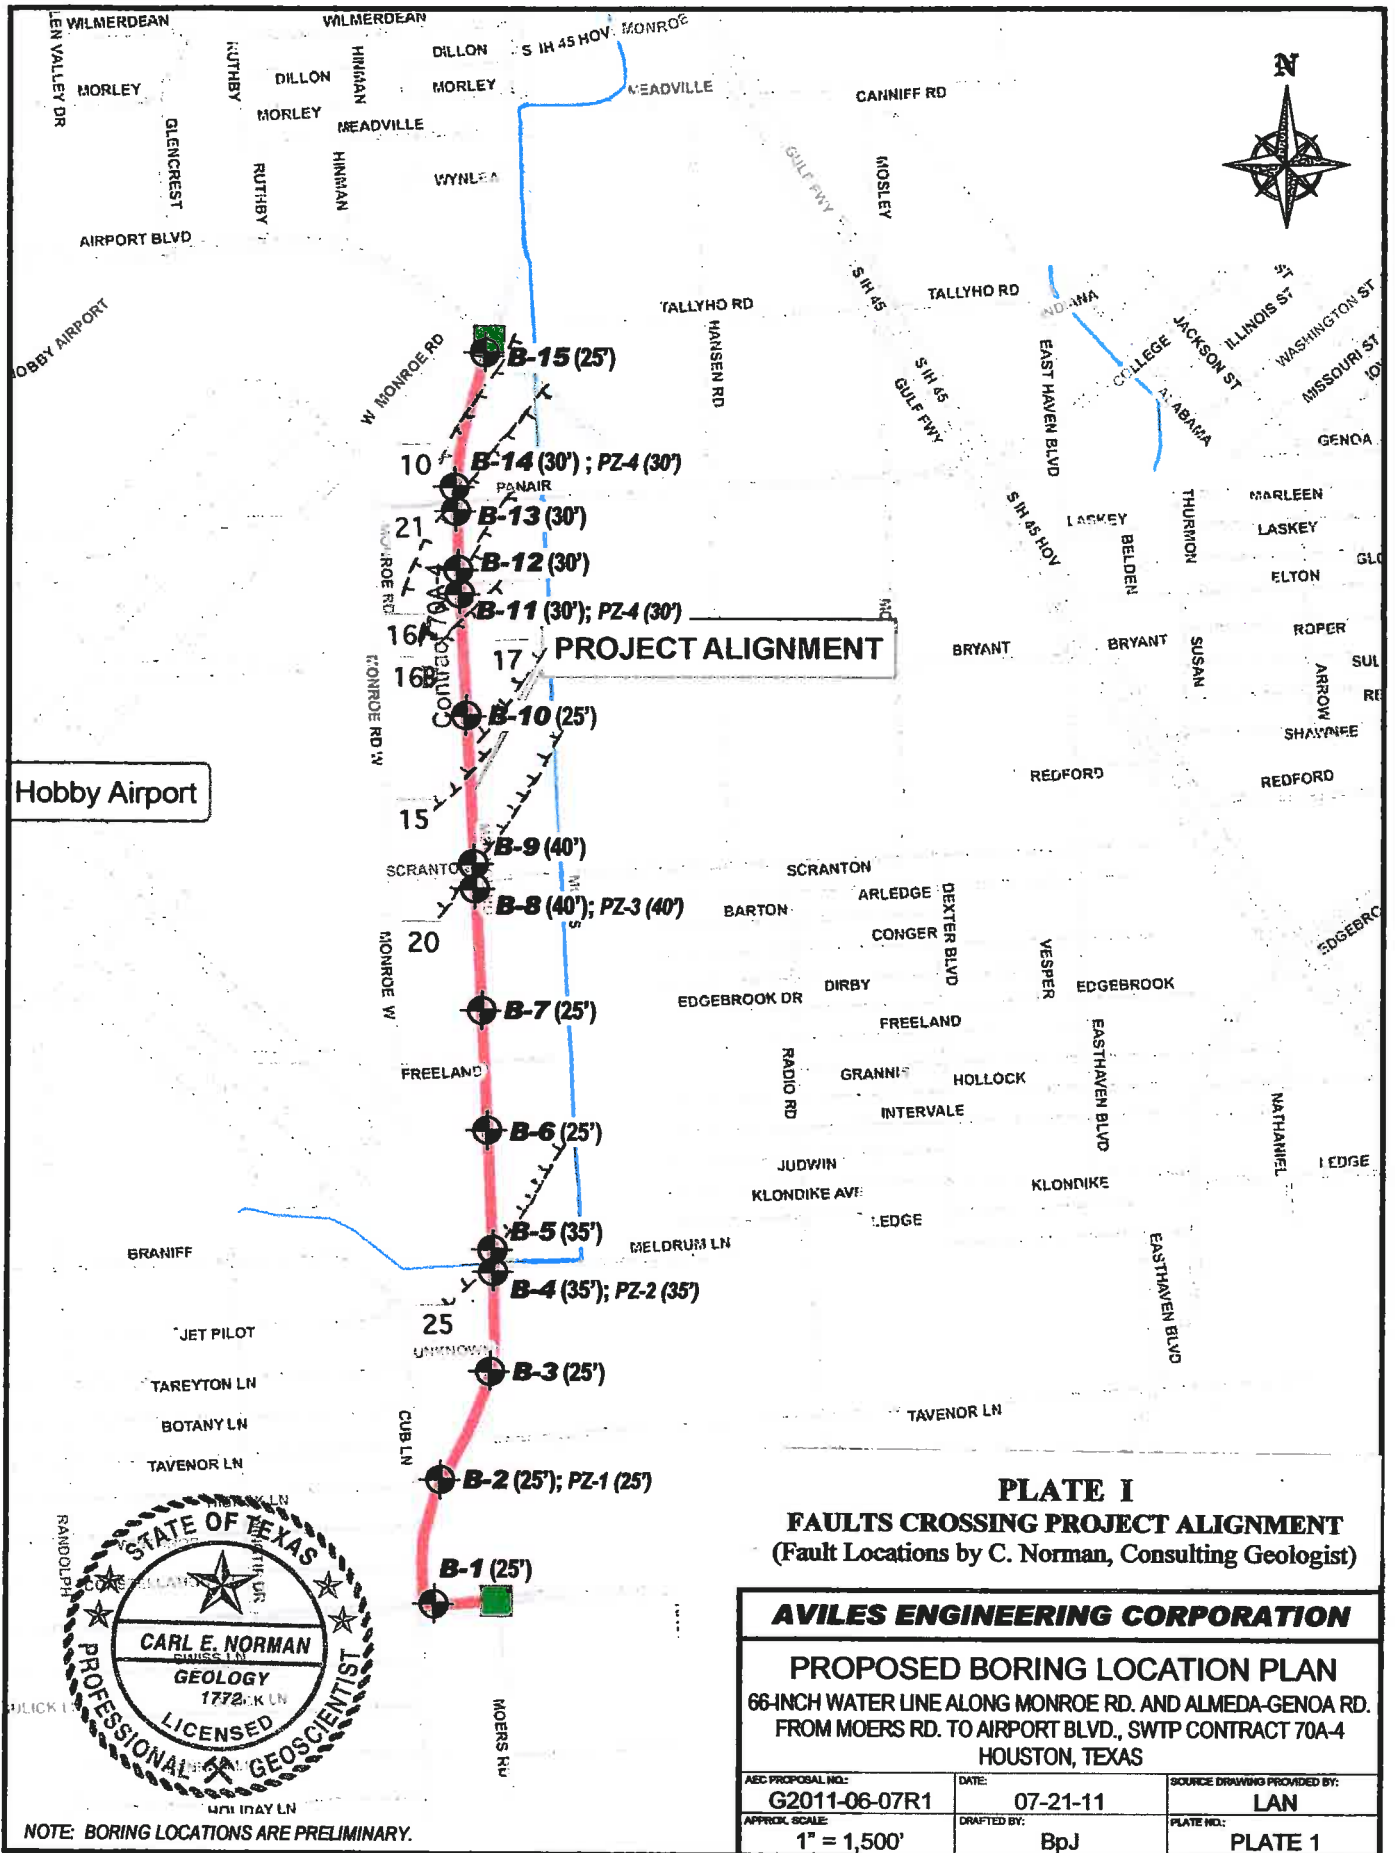
PLATE I
FAULTS CROSSING PROJECT ALIGNMENT
 (Fault Locations by C. Norman, Consulting Geologist)

Each of the 7 faults to be crossed by the pipeline trend 30 to 35 degrees east of true north, while Monroe Road trends due north (Plate I). At ground level, all 7 faults disturb near-surface soils in deformation zones a few tens of feet wide, measured perpendicular to their trends. However, the "apparent width" of the deformation zones along Monroe Road will be approximately 85% greater than their true width, due to the crossing angle. A single exception is Fault No. 10, which crosses Monroe Road at a small angle a few hundred feet south of Airport Boulevard. Here the roadway remains in the fault zone for a distance of at least 200 feet. No fault crosses the small east-west section of the route between the Monroe-Almeda Genoa intersection and Moers Street.

The surface trace of Fault No. 10 appears only a few tens of feet east of the north-bound lanes of Monroe Road at Airport Boulevard. It crosses Monroe's centerline about 400 to 600 feet south of the centerline of Airport Boulevard. Here the fault trends N33E and dips to the southeast. South of Airport Boulevard, at the west side of the Shell service station, an 85-foot long open crack in concrete pavement parallels the fault trace. The crack is about 30 feet east of the north-bound lanes of Monroe Road. There are other similar pavement cracks in this vicinity, but none as pronounced. I did not find an unusually high frequency of pavement cracks or an unusual warping of pavement where the fault crosses the north- and south-bound lanes of Monroe.

Fault 21 extends 1.9 miles in direction N30E, crossing the centerline of Monroe Road approximately 70 feet north of the centerline of Panair Street. Ground southeast of the fault trace moves downward and southeastward relative to ground on its northwest side. The fault trace crosses the centerline of Panair Street 50 to 55 feet west of the centerline of Monroe. Thus the local trend of the fault is N37E. I reported these data after completing studies of the fault in November 1982 and June 1999. Judging from 1982 observations of man-made structures disturbed by the fault, its zone of intense deformation in the Monroe-Panair area is approximately 20 feet wide. Due to uncertainties in determining a precise location for the fault trace, it was deemed prudent to establish a 50-foot wide fault zone. The reports noted that "new" Monroe had been constructed during the summer of 1982, and that its location had been obscured in the "new" Monroe-Panair area. The result was that mapping of the fault relied on previous field observations and a study of aerial photographs.

Based on aerial photographic evidence, the northernmost segment, Fault 16A, is about 1100 feet long. It crosses the centerline of Monroe Road in direction N30E approximately 640 feet south of the centerline of Panair Street. I found no clear evidence of the fault on either the north- or south-bound lanes of Monroe.

Aerial photographic lineaments associated with the trace of Fault No. 16B trend in direction N39E. Ground is downthrown on the southeast side of the fault. Where the fault crosses the centerline of Monroe, approximately 920 feet south of the centerline of Panair Street, there is presently no clear field evidence of its existence. However, about 100 feet southwest of that point the fault may be revealing its presence in the form warped sidewalk at the west edge of Monroe, as well as a substantial foundation crack 30 feet south of the northeast corner of a commercial building occupied by Pantex-Emmerfield Systems.

The trace of Fault No. 15's southern segment crosses the centerline of Monroe in direction N32E approximately 875 feet north of the centerline of Scranton Street. The paved surfaces of both the north- and south-bound lanes of Monroe are uneven, but not significantly warped where the fault lineament crosses them. At the west edge of Monroe's southbound lanes is a steel pole at the south edge of a driveway to the Wire Coil Manufacturing Company. An employee of the plant stated that after a heavy rainfall, water stands on Monroe northwest of a line passing from the pole northeastward across Monroe. Those conditions correspond well with the direction and movement sense of Fault No. 15. Along the east side of Monroe I found no field evidence of fault-related disturbance to buildings, parking areas or a circular pool, all of which lie along the aerial photographic lineament associated with this fault. Those structures appear on a 1998 photo, but not on one taken in 1990. The fault is likely there, but is currently inactive.

The trace of Fault No. 20 crosses the centerline of Monroe approximately 160 feet north of the centerline of Scranton Street. In turn, it crosses Scranton about 100 feet west of the centerline of Monroe. The local trend of the fault here is N32E. Ground northwest of the fault trace moves downward and northwestward relative to ground southeast of it.

Fault No. 25 is the southernmost fault that crosses Monroe Road between Airport Boulevard and Alameda Genoa Road. It trends in direction N34E and dips to the northwest. Its aerial photographic lineament extends for approximately 1.9 miles from a point near the intersection of Gulf Meadows Drive and Fuqua Street to a point about 0.25 miles northeast of the intersection of Monroe Road and Meldrum Lane.

Fault zones in the Hobby Airport area are approximately 20 feet wide, but because the 6 of the zones trend only 30 to 35 degrees from the direction of the planned waterline route, flexibility for the waterline should be provided through approximately 280 feet of disturbed ground. Adding in Fault No. 10, which crosses Monroe at a much smaller angle, the total length of the zone to be protected rises to about 500 feet. When uncertainty as to the exact location of the faults is also taken into account, the total length of the protection zone increases to about 1000 feet.

Normally Phase I fault investigations deal with only a single fault that impacts a project area. This project offers a much more complicated scenario where a waterline must cross 7 closely spaced, active faults. Most of the extensional strain of ground between Airport Boulevard and Alameda Genoa Road is localized at the fault zones, but it should be anticipated that some may accumulate in areas between those zones. Rather than thinking about dealing with each fault separately, a mitigation plan that would address all the faults, as well as the ground between them, may be a better approach.

Oil and gas pipeline companies have operations in the dry southwestern states where large desiccation cracks form to depths of 10 feet or more. Here engineers must design shallow-buried pipelines that will accommodate large amounts of extensional ground strain. Their solution to the problem is to lay the pipeline in an open trench wide enough to allow the pipe to meander from one side of the trench to the other. As horizontal ground strain accumulates, the pipeline straightens somewhat without rupturing. The meander simultaneously provides flexibility that will accommodate vertical strains.

If plans call for deep burial in poorly consolidated soils, a meandering waterline could be placed in a sufficiently wide slurry trench. Whether a meandering line could be placed in deep trenches where a vertical shaft-horizontal bored tunnel construction method is used would have to be addressed by pipeline engineers.

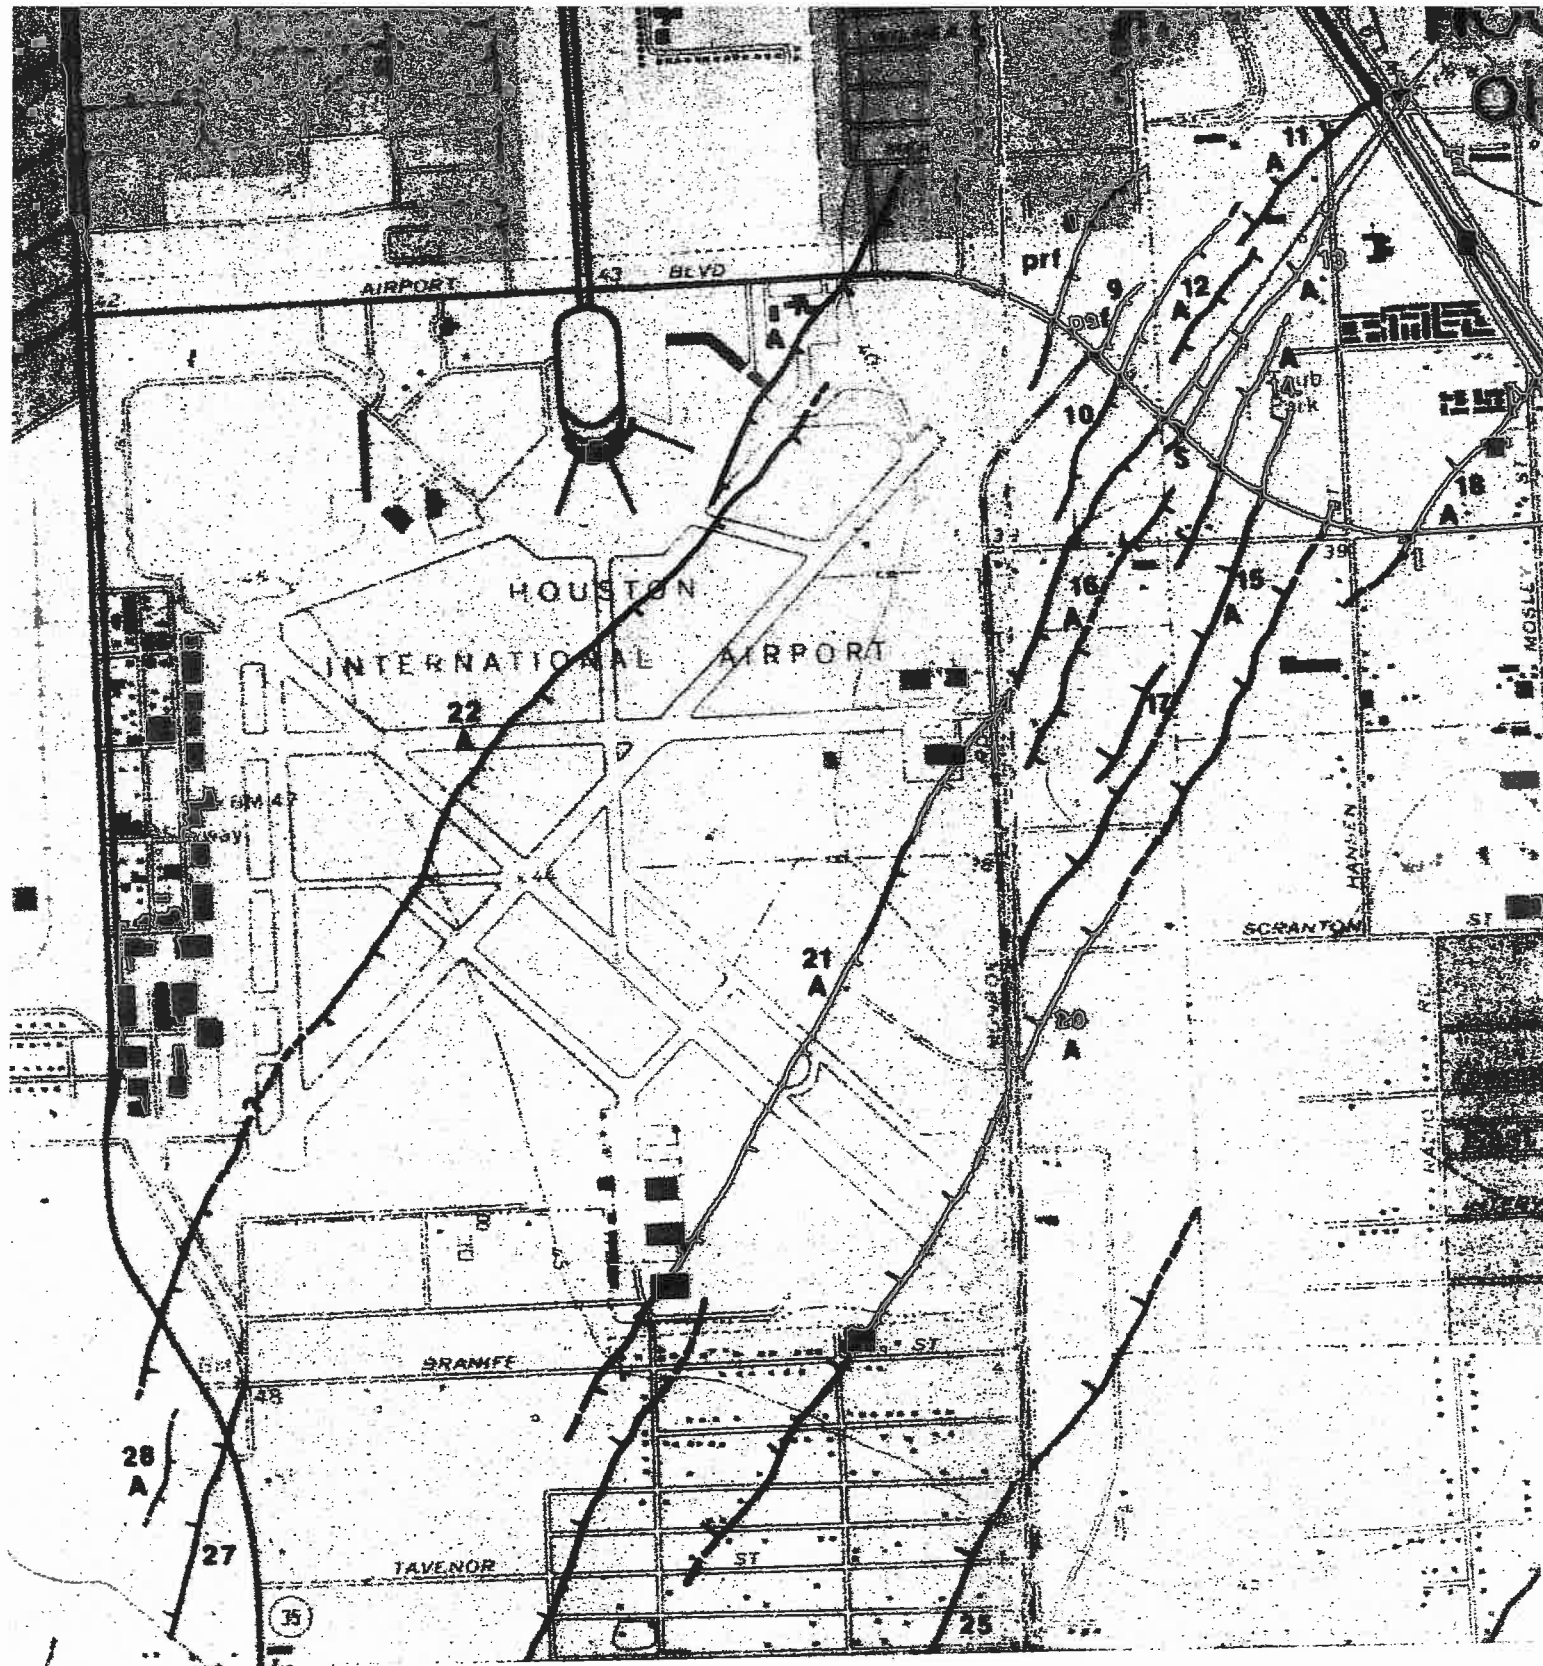
PLATE II

surface faults in southeastern Houston metropolitan area, Texas, U.S.G.S. Open-File Report 78-797, 20 pp.) and from 19 proprietary reports written mostly in the 1980s and 1990s. Plate II is a copy of a portion of Verbeek and Clanton's map that covers the Hobby Airport area. Note that Monroe Road on that map is "Old Monroe", which is now part of Hobby Airport. "New" Monroe Road is approximately 700 feet east of it. The report does not discuss individual faults in detail.

Below are separate descriptions of the 7 surface faults, applicable to the area where they cross Monroe Road between Airport Boulevard and Almeda Genoa Road. Each fault is designated by the number Verbeek and Clanton assigned it in 1978 (Plate II).
